Building 41

Chapter 31

Lisa Yeomans

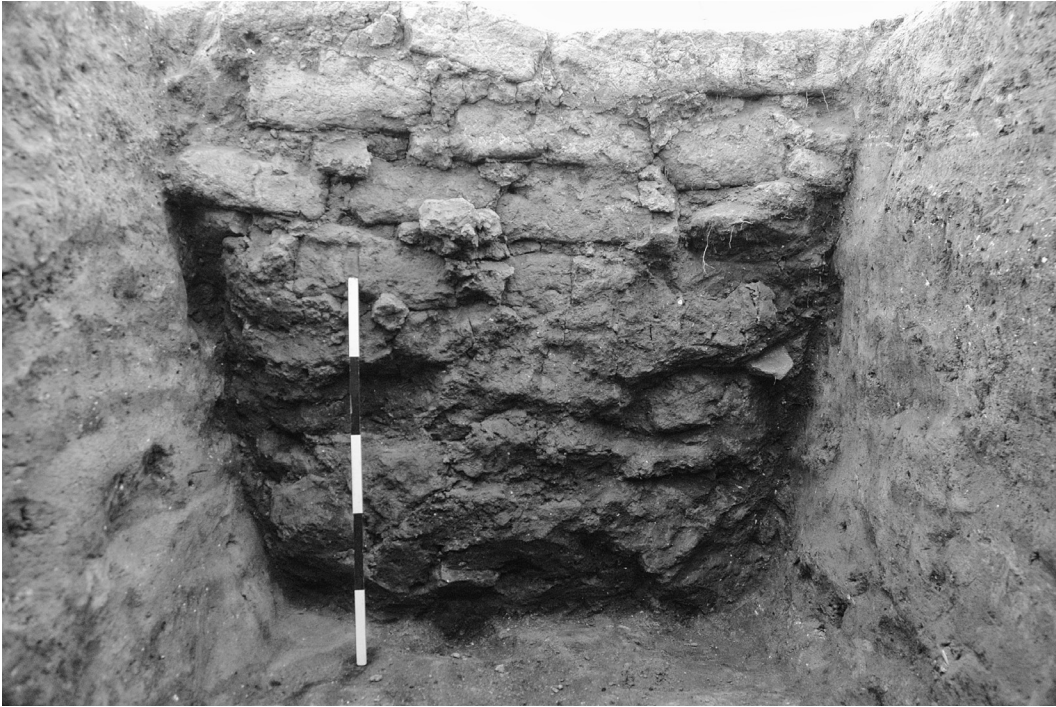
Figure 31.3. Mudbricks (12634) set into the top of the foundation of wall F.1217 to support a doorway between Sp.217 and Sp.222 (Photograph by Jason Quinlan).

F.1217. As the construction cut was not as deep and not flush against the original foundations, the southern wall F.1217 would have been already standing when this space was added. During the construction of the annex, a timber (13196) was laid across the top of the cut in part of the southern wall possibly to stop slumping at the top. Although this space was a later addition it still appears to have been built during the initial layout of the building as in the dividing wall between Sp.222 and Sp.217 there is evidence for a robbed out threshold. Mudbricks (12634) were set into the foundation cut separated by 1.13m in the middle of the north side of Sp.222 (Fig. 31.3). These were probably supporting an opening between the two spaces and a cut (12633) indicates that the material supporting the doorway had been robbed out after the abandonment of the building. As the entrance-way between Sp.217 and Sp.222 was built during the initial construction, it confirms that the southern space was built at the same time as the rest of the building even if the foundation cuts did not join.

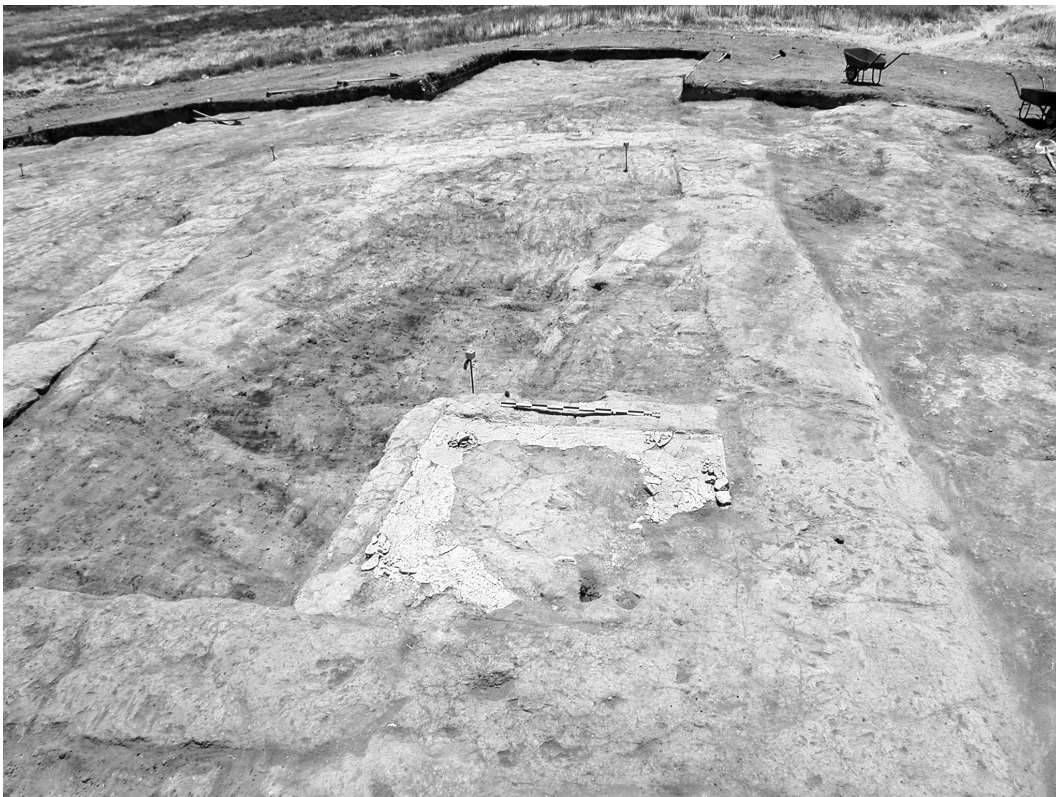
Figure 31.4. Floor plaster (12399) in Sp.215 and surrounding wall foundations cutting Neolithic deposits (Photograph by Jason Quinlan).

Sp.215, the small room in the northwest corner of Sp.212, was defined by a separate and well-constructed floor whilst the floors in the rest of the building rarely survived. For the construction of the floors a square cut (12626) was filled with a clay make-up layer (12608). The cut did not extend up to the foundations of the walls of Sp.212 and the gap left between them indicates that the walls were already built. A solid, white plaster floor (12399) covered the interior of this small room (Fig. 31.4). The make-up for the plaster floor also sealed a feature F.1470 comprising of an oval cut measuring 1.8m by 0.47m by 0.19m. The fill contained two tree trunks placed parallel to each other. One interpretation is that it may represent some form of drainage channel in association with the hard mortared, and possibly water proofed floor above or it have been to reinforce the floor above.

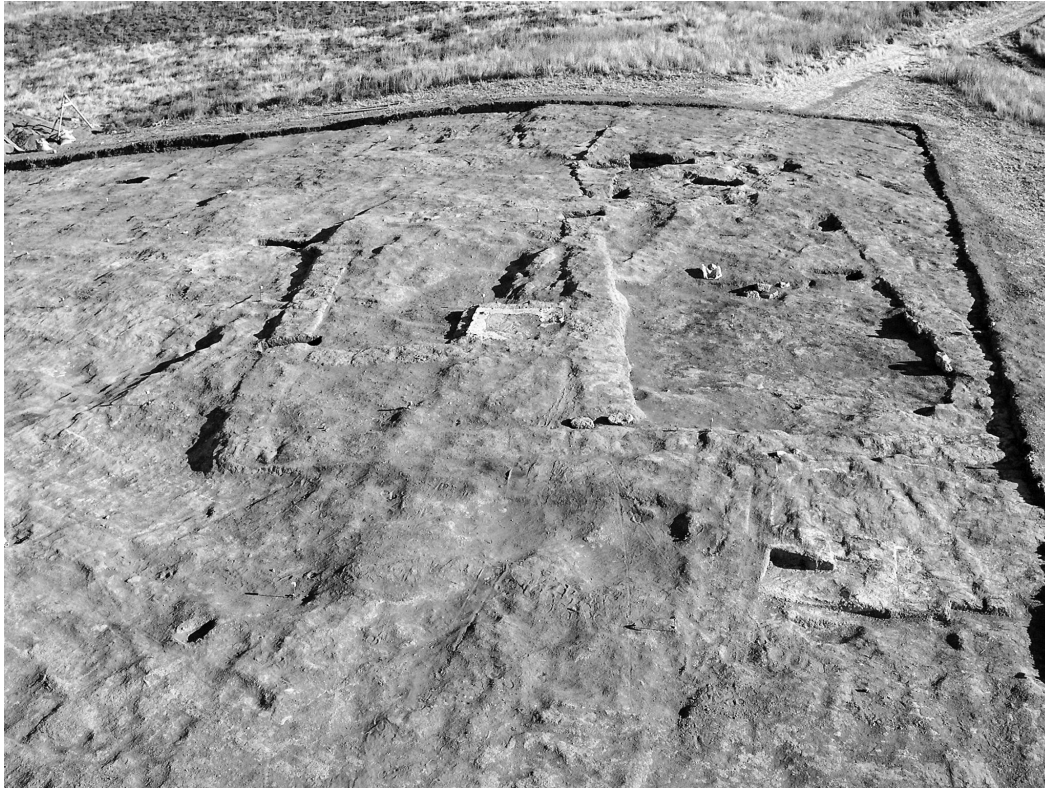
Figure 31.5. Overhead photograph of B.41 (Photograph by Jason Quinlan).

ing of pot sherds recovered from the excavation suggests that B.41 was built during the Selçuk period or perhaps slightly later. A number of pits surround the building, but no work has been done on these to suggest which, if any, were contemporary to the building. Analysis of contemporary waste discarded in the pits may, in the future, help indicate the function of this structure (Fig. 31.5).
